Arlington Reservoir Master Plan

2018

INTRODUCTION AND EXECUTIVE SUMMARY

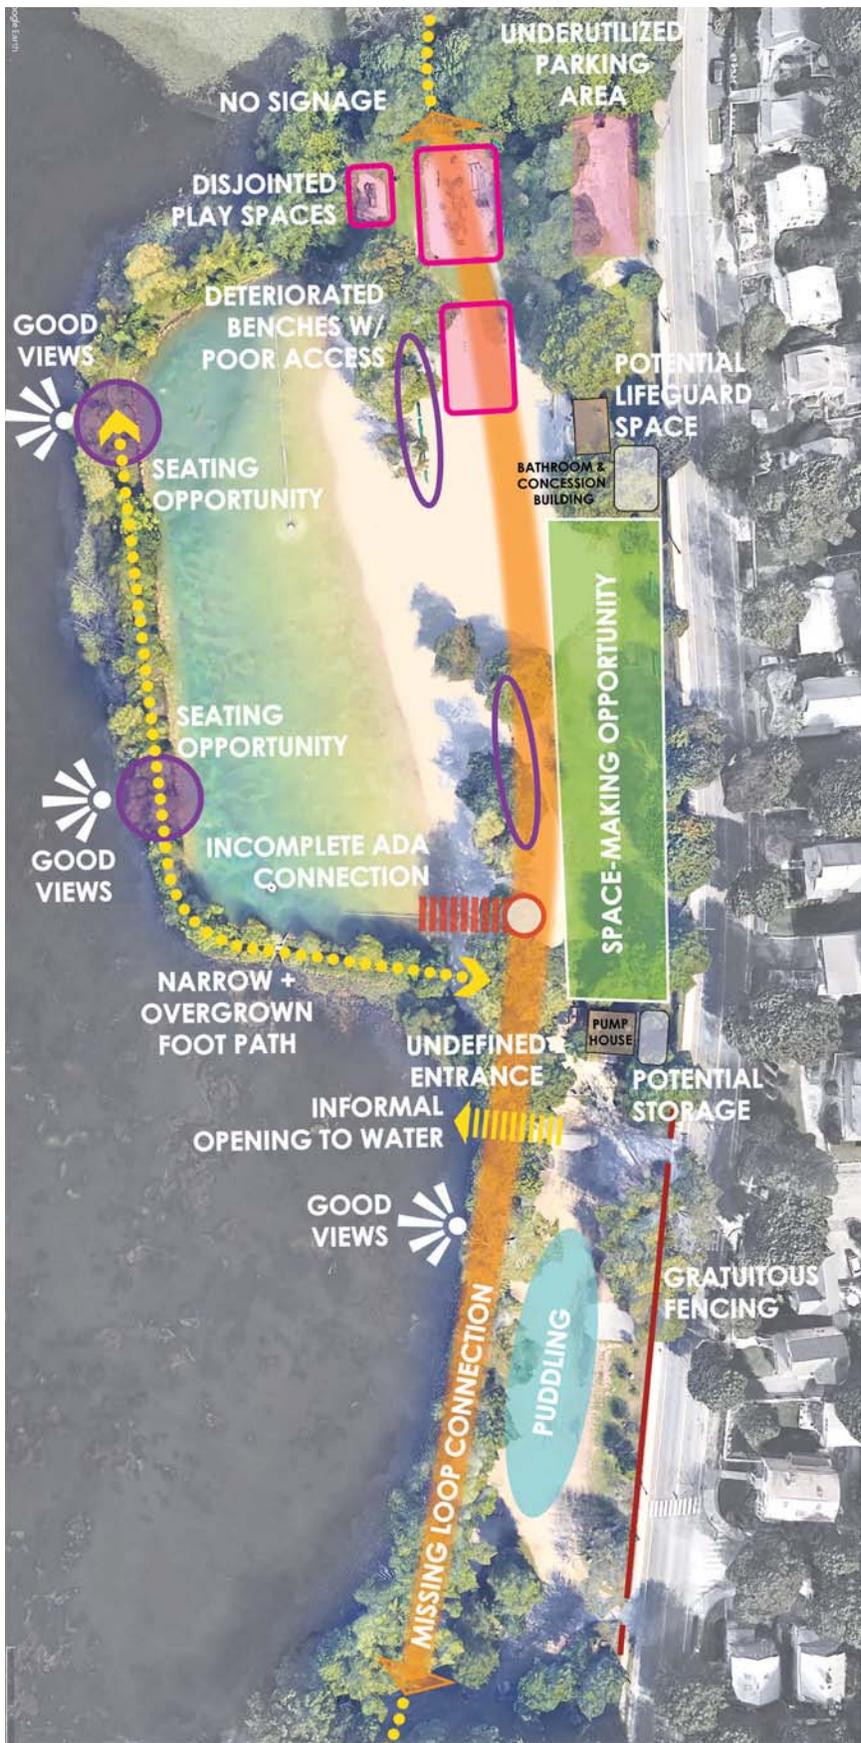
Analysis diagram of the beach and parking area, showing trail conditions, incomplete or non-compliant walking path connections, seating and viewing opportunities, deteriorated perimeter fencing and disjointed programmatic elements

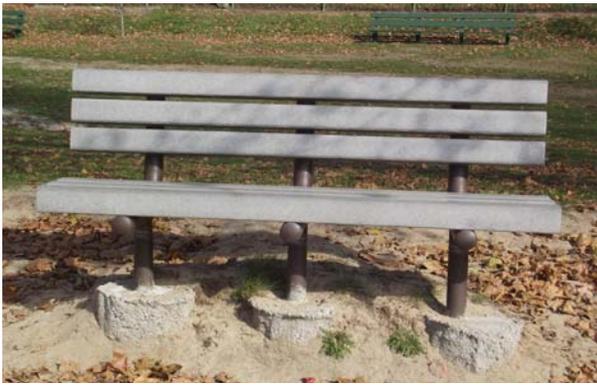
Typical bench condition

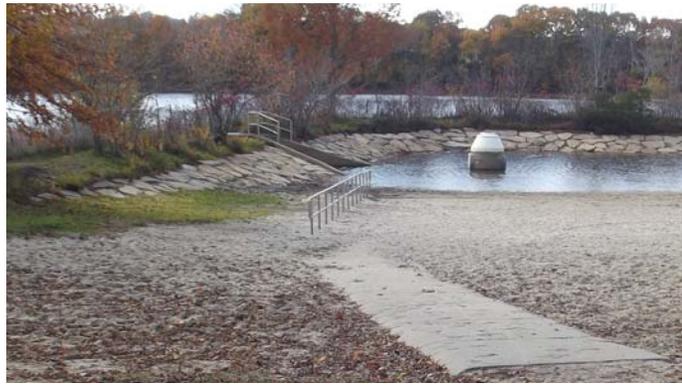
Non-ADA compliant concrete pathway and handrail system in foreground; the berm in background.

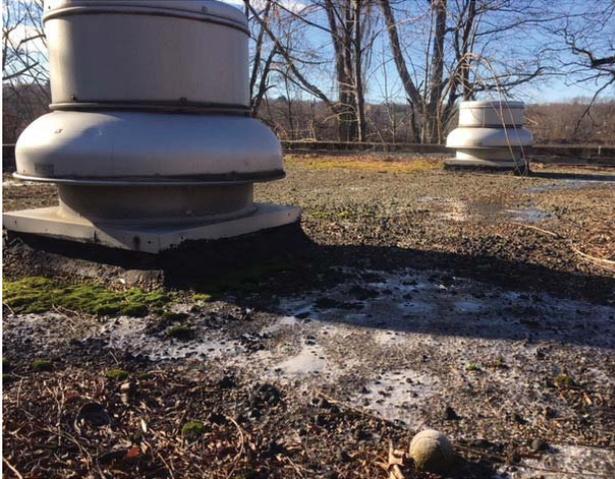
Roof - The roof assembly consists of a built-up tar-and-gravel membrane over a metal deck. It is not known if any thermal insulation or vapor retarder is present in the roof system. There is a single interior drain at the southwest corner of the roof. The condition of the roof is fair to poor, with leakage noted at the interior.

Pump house roof condition

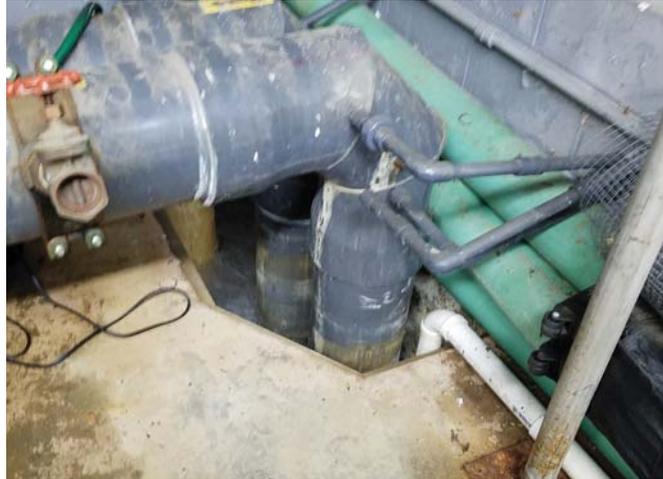
Interior flood condition with intake piping to swimming area

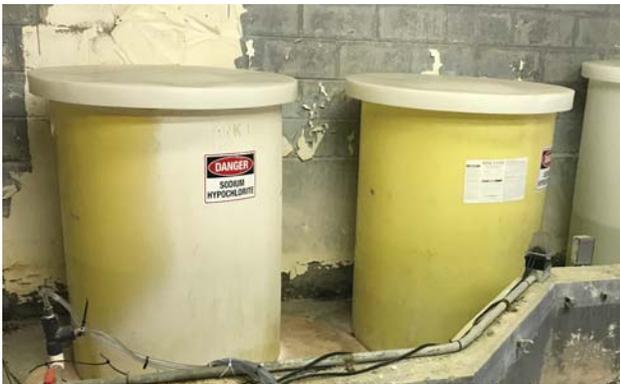
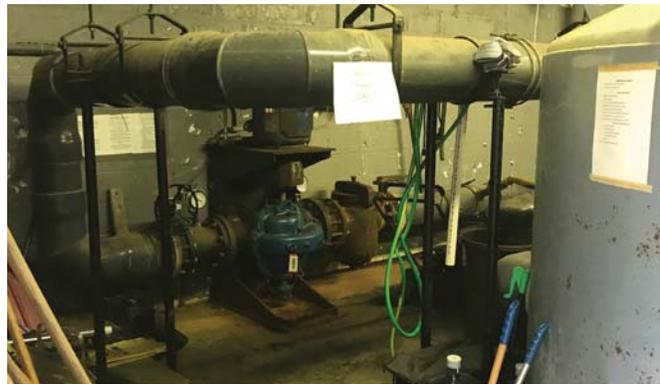
There are many challenges with the current filter system, as noted below:

- The filter sand has not been changed in over ten years. The vessel is rusted. Operation has not been able to properly backwash the vessel and it is unknown how much sand is still in the filter.
- The pump is currently a vertically-mounted pump, however, it is a flood suction pump that is above the static water level, which makes it challenging to prime.
- The chemical controller no longer works and it doesn't appear to have worked for years.
- Instrumentation, such as flow meters and pressure gauges, do not function properly.
- The chemical injection system is not interlocked with the pump.
- The Town uses domestic water to supplement filling the swimming area when the water is too low.
- Site valves either do not open and operate or are difficult to operate.

Chlorine Disinfectant Holding Tanks

Vertically-mounted Pump and Strainer

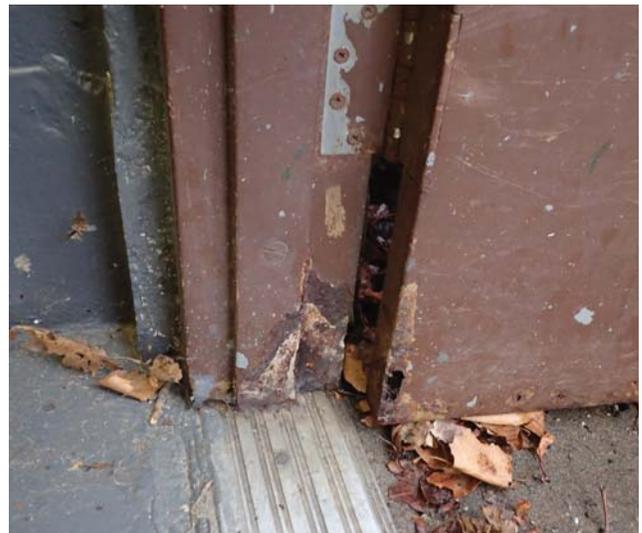
Typical door and frame condition at a restroom

For door openings, there are three single steel exterior doors. The doors and frames are showing some corrosion at their lower edges. Hardware operation was not verified. The doors and frames are not thermally broken. The presence or condition of weatherstripping was not verified.

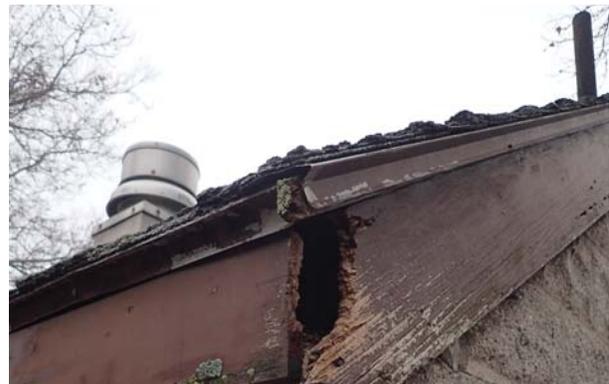
Wood fascia board in poor condition

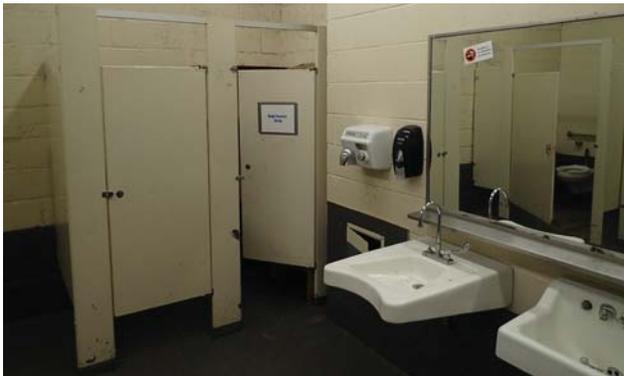
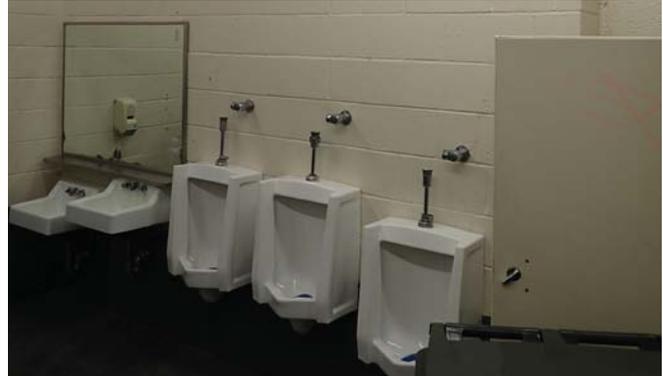
Women's room partitions and fixtures

Men's room partitions and fixtures

Toilet Partitions & Accessories - Toilet partitions and accessories, including grab bars, mirrors, shelves, hand dryers, soap and toilet paper dispensers, etc., are in fair to good condition, but should be considered for replacement as part of an overall upgrade to the toilet rooms.

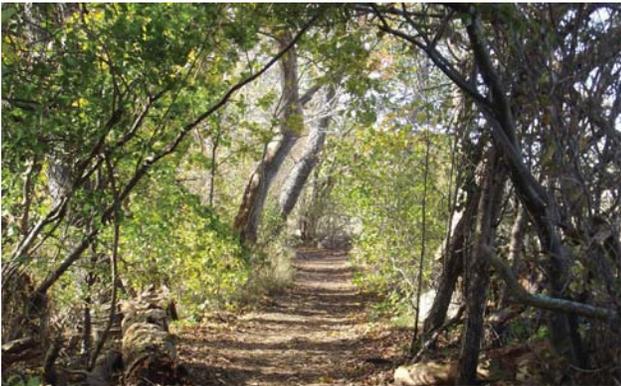
Trail condition next to Busa Farm

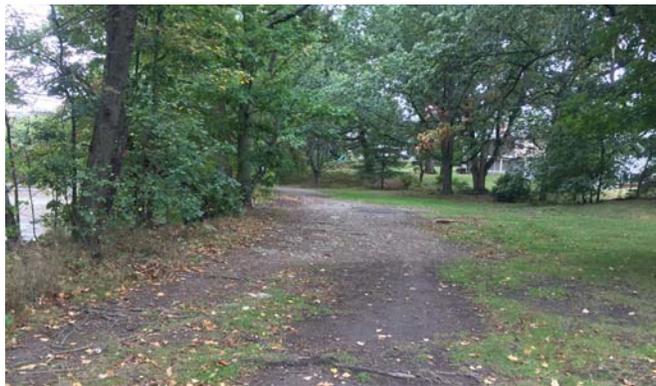
Ambiguous trail condition next to Rindge Park

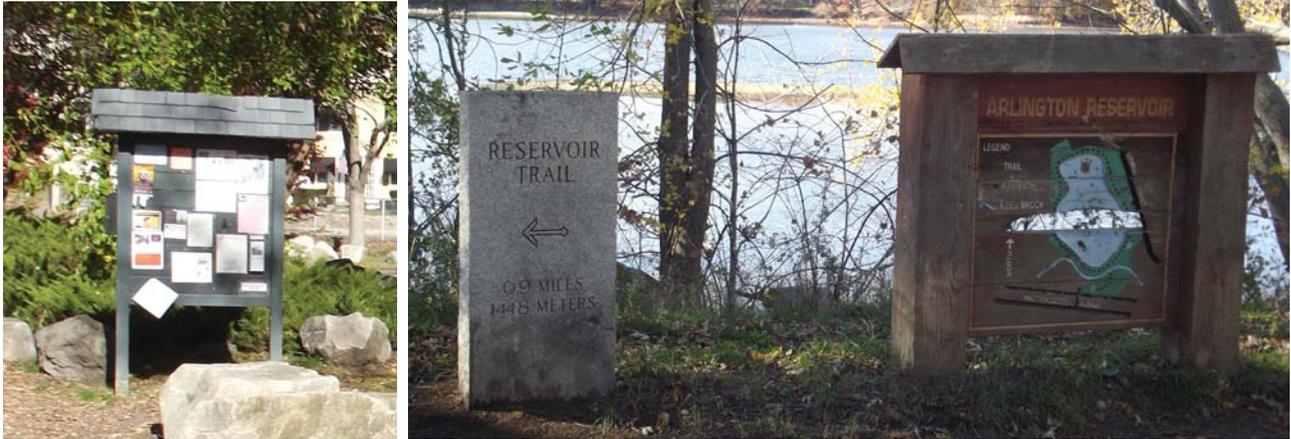
Community board/trail map kiosk Granite mileage marker and deteriorated wooden kiosk

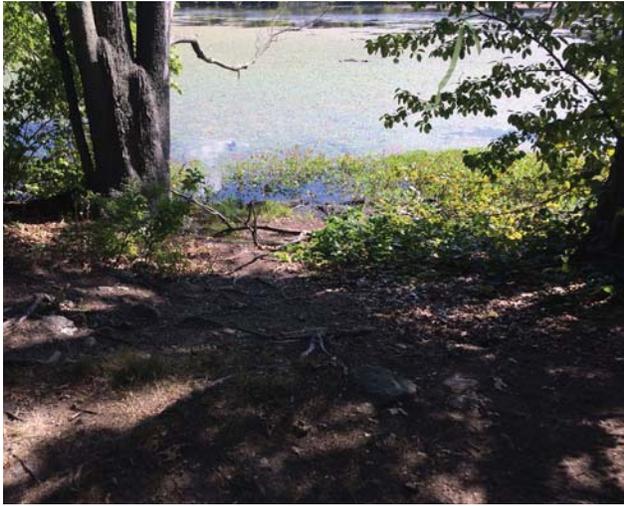
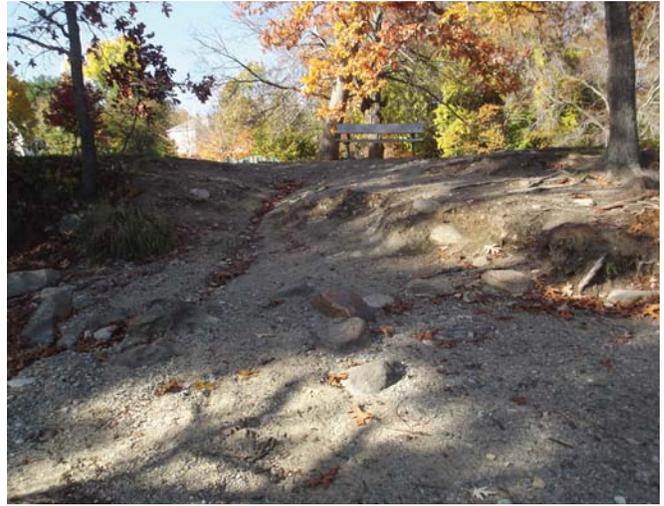
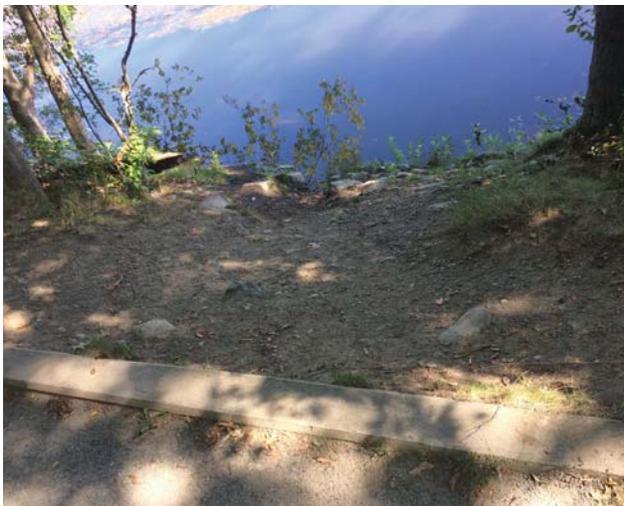
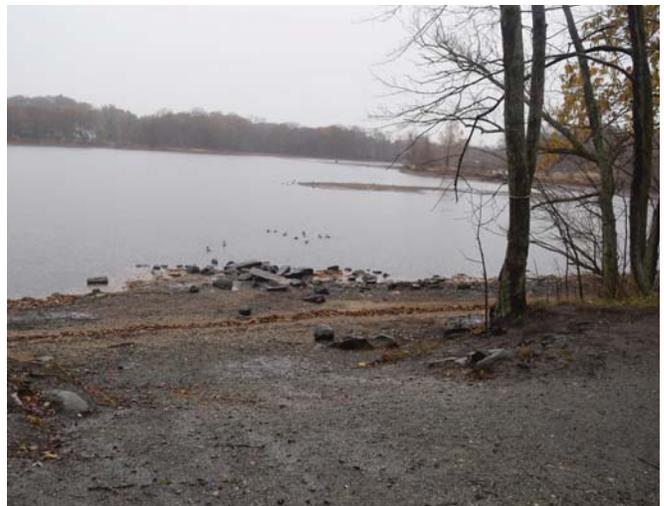
the park to access the water of the Res. The features are limited in extent and occur in isolated areas, therefore they are not caused by wave action. A few, especially near hard packed areas, may also be the result of stormwater runoff into the Res, which is most prevalent near the parking lot. There are also erosional conditions present around the existing stormwater outfalls, which are in disrepair.

Condition along the northern shoreline

Condition at Rindge Park

Condition along the southwestern shoreline

Condition along the southeastern shoreline

In order to avoid further disturbance/erosion of these areas proper bank stabilization, resource area protection measures, and proper stormwater controls should be implemented. This would include curbing the parking lot to prevent water from running down the banks of the Res. Careful consideration should be made as to how to prevent further erosion from occurring in these and other areas, which will be discussed in the "Preferred Master Plan" section of this report.
