Wetland Delineation Report

ARLINGTON RESERVOIR
ARLINGTON / LEXINGTON, MA

WETLAND DELINEATION REPORT

Prepared for
TOWN OF ARLINGTON RECREATION DEPARTMENT

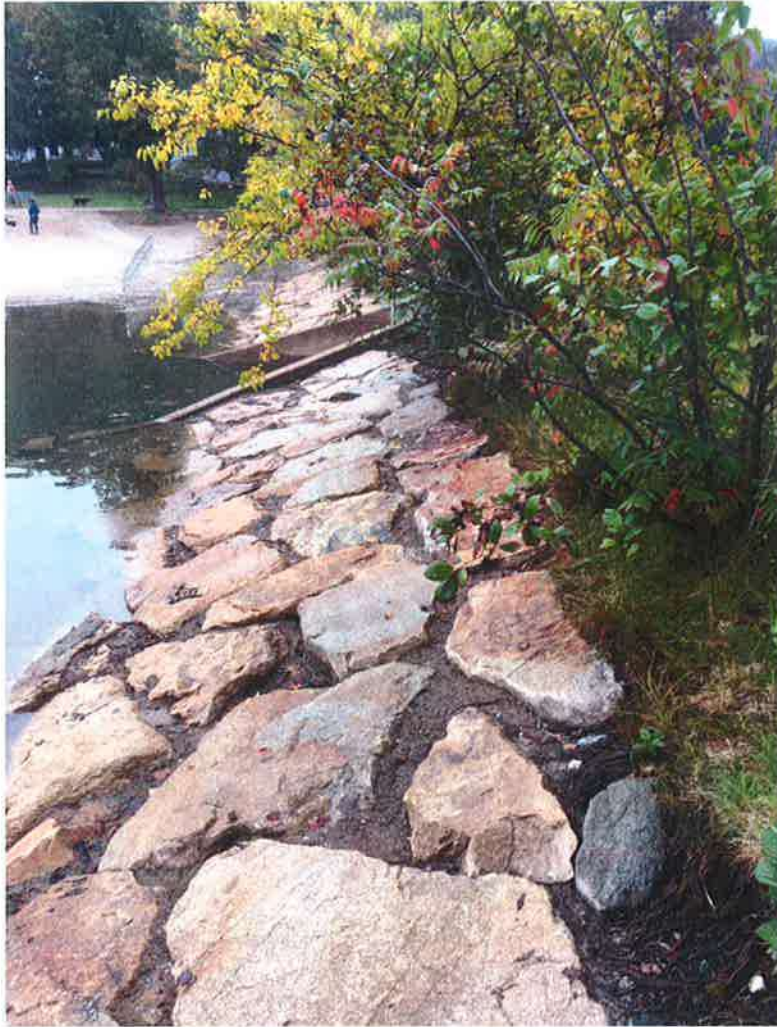
Photograph 1. Inner bank of berm, southern edge, looking back towards bathing beach.

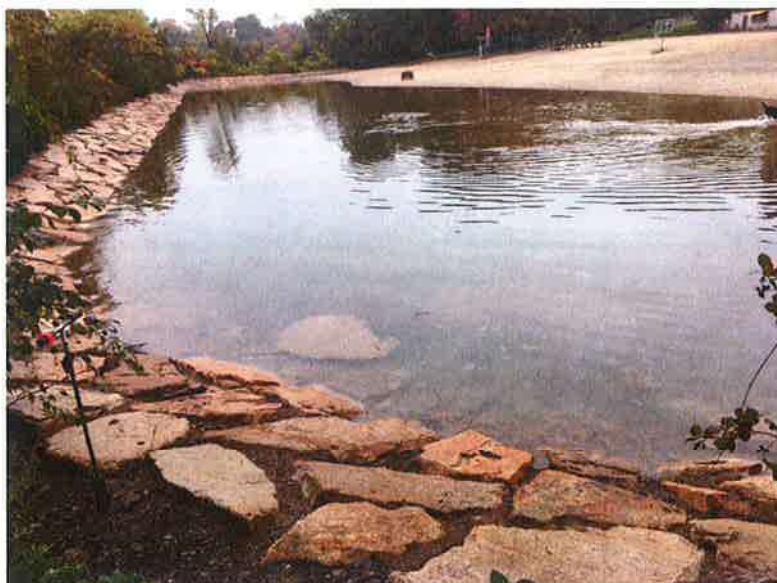
The south, west, and north bank of the inner bank of the berm that contains water in the bathing beach area is lined with flat rock set in concrete (see photographs in Appendix A). Above the flat rock is soil and vegetation. The top of bank was determined based on the undercutting of the soil just above the flat rock.

Photograph #2. Inner bank of berm, western and northern edge, looking north.

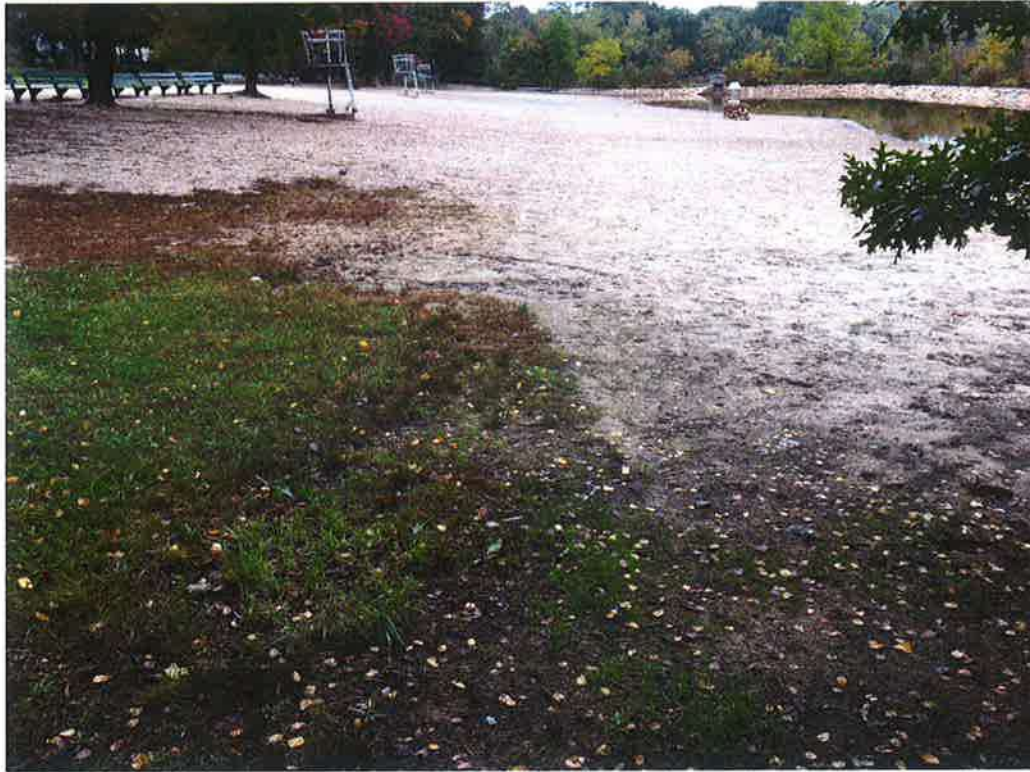
The eastern shore is a manmade area consisting of a sandy beach which has a gentle slope as it transitions from the upland down into the water. On the day of the investigation, that was approximately 3 – 4 feet below normal pool elevations. The top of bank on the beach area was determined based on the limit of vegetation on both the northern and southern ends of the eastern bank. This vegetation was a manicured grass area that extends upgradient into the upland area. The downgradient most point of this vegetation was considered the top of bank. See Appendix A for photographs of this area/bank limit.

Photograph #3. Eastern bank of bathing beach based on downgradient most limit of vegetation.

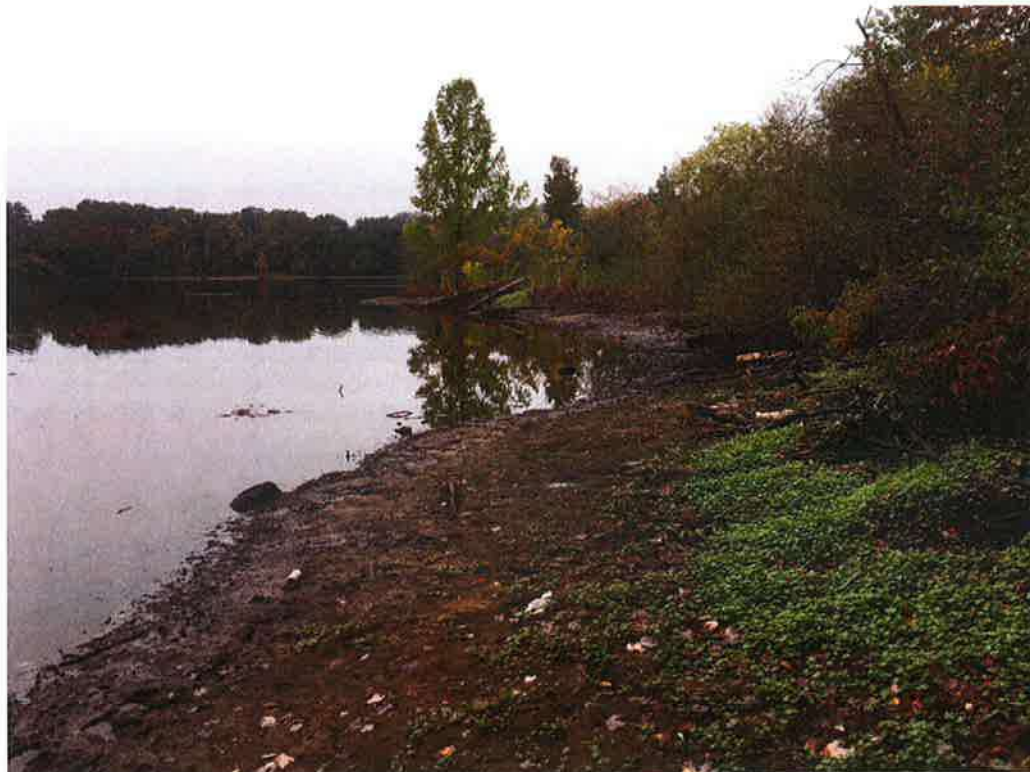
The outer bank of the berm that creates the bathing beach area was considered a bank which contains the Arlington Reservoir and consists of soil and vegetation. As noted above, water levels were approximately 3 – 4 feet below normal elevations. The top of bank was determined using the undercut area of the bank. Wetland flags TOB-B1 through TOB-B23 were left in the field to show the top of the outer berm bank.

Photograph #4. Outer bank of berm. Note low water elevation.

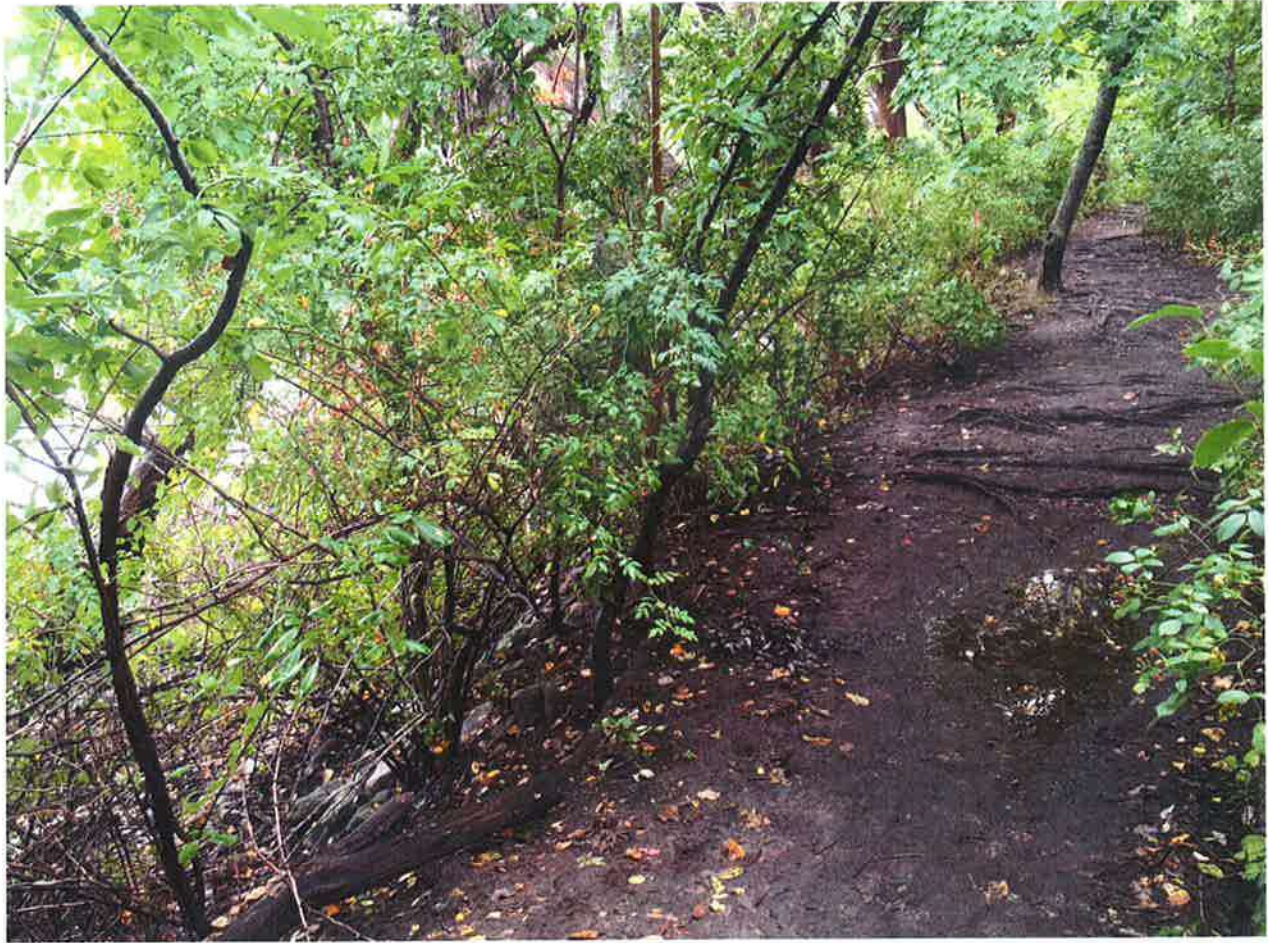
A small (approximately 50 linear feet) project will be proposed to improve a walking path, improve soil erosion conditions and conduct invasive species management. Because the walking path is near the bank of the reservoir, approximately 120 feet of the top of bank was delineated. The top of bank was determined using the undercut area of the bank. Wetland flags TOB-C1 through TOB-C5 were left in the field to show the top of the bank.

Photograph #5. Walking path project area. Reservoir and bank to the left of path.

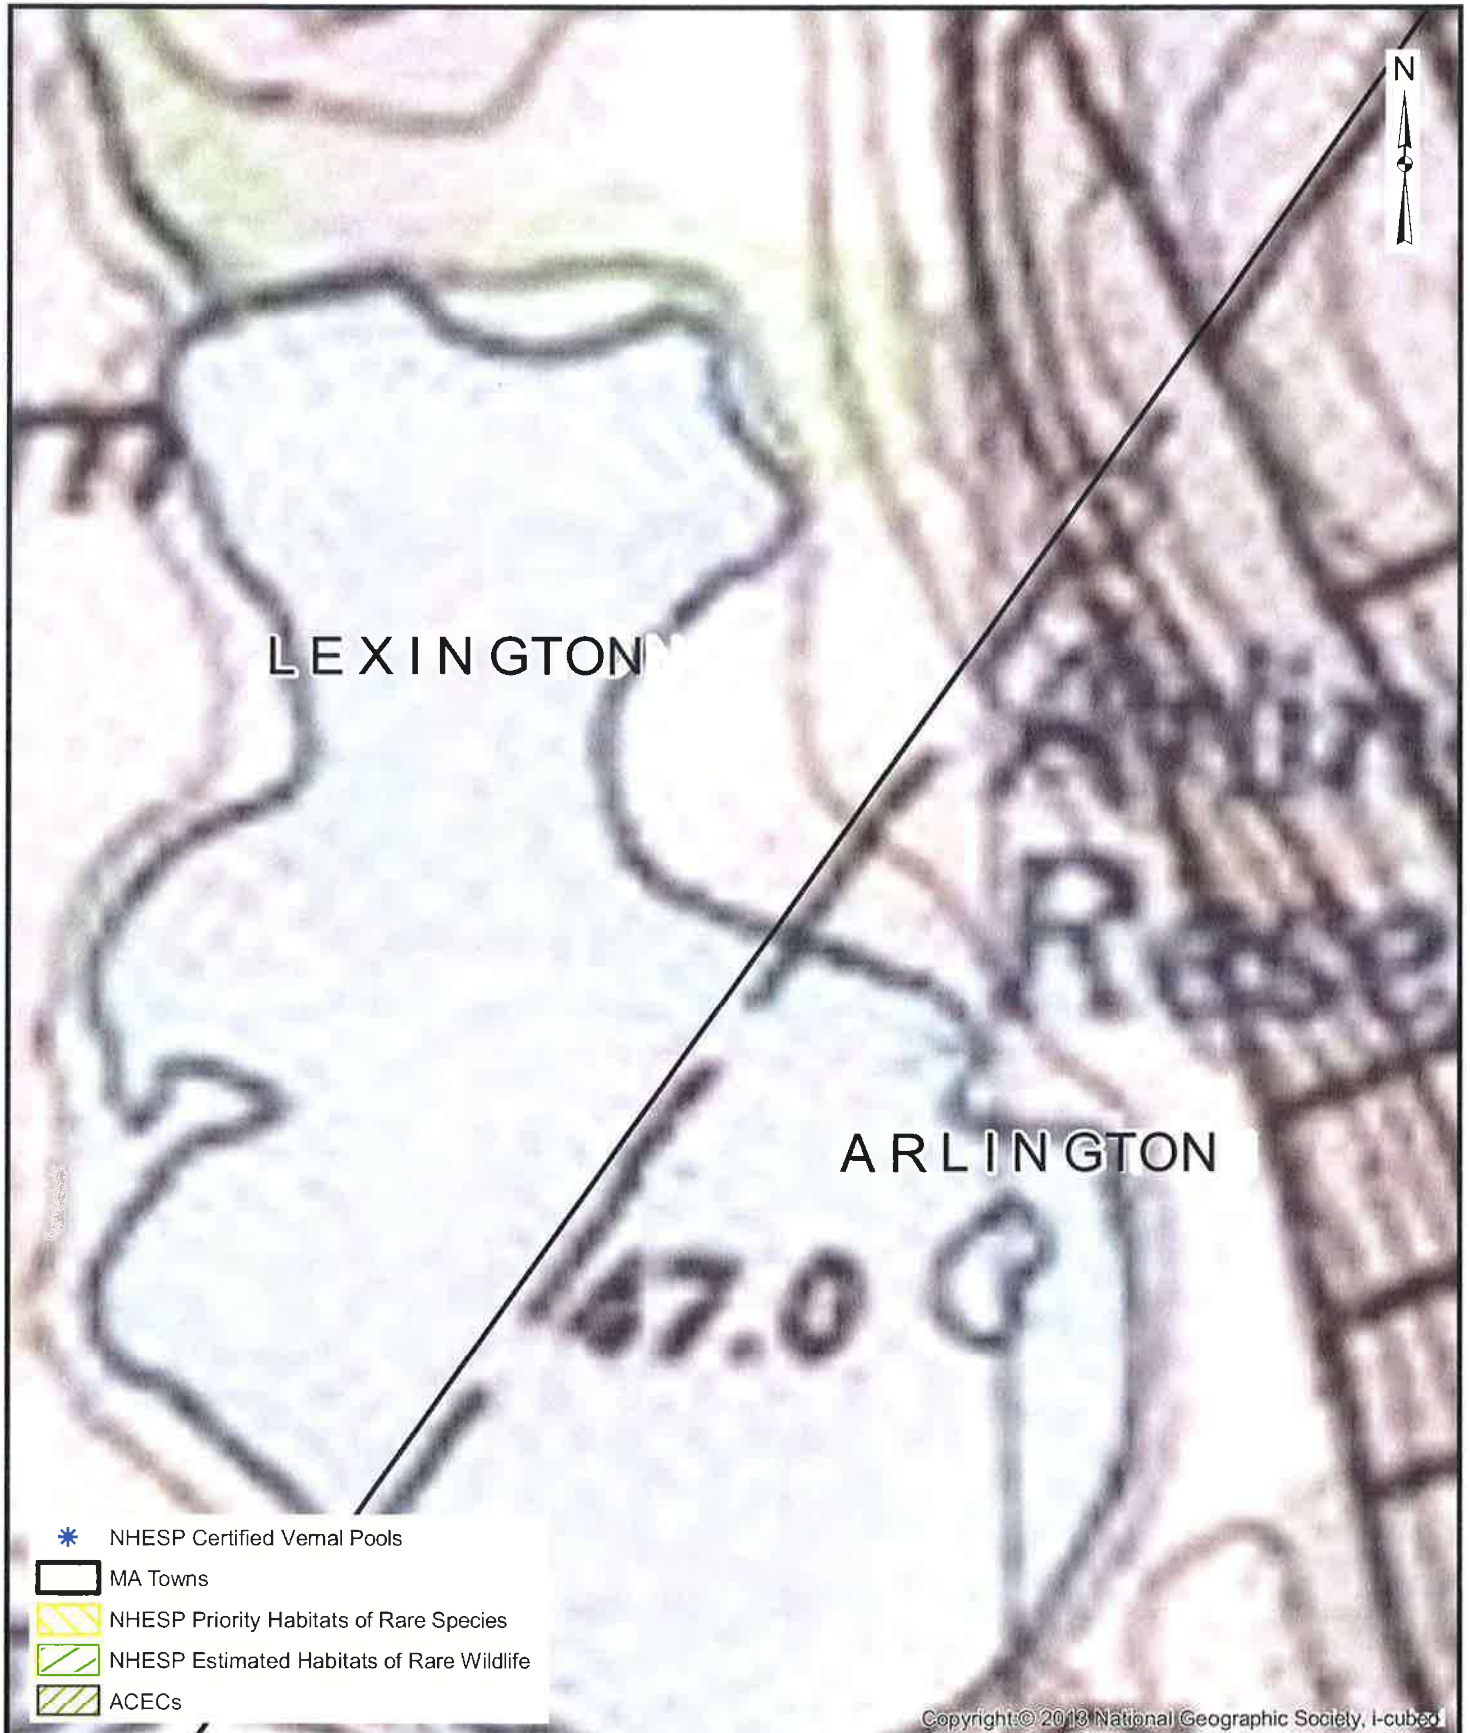
Besides what was noted above, Weston & Sampson created an environmental receptors map of the site to determine the presence of other protected areas (Appendix B, Figure 3). The data source of these map layers was the Massachusetts Geographic Information System (MassGIS). These areas included:

- NHESP Priority Habitats of Rare Species
- NHESP Estimated Habitats of Rare Wildlife
- NHESP Certified and Estimated Vernal Pools
- Areas of Critical Environmental Concern

None of the above mentioned resource areas were located in the inspections area.

FIGURE 3
Arlington Reservoir
Arlington/Lexington, Massachusetts
ENVIRONMENTAL RESOURCES

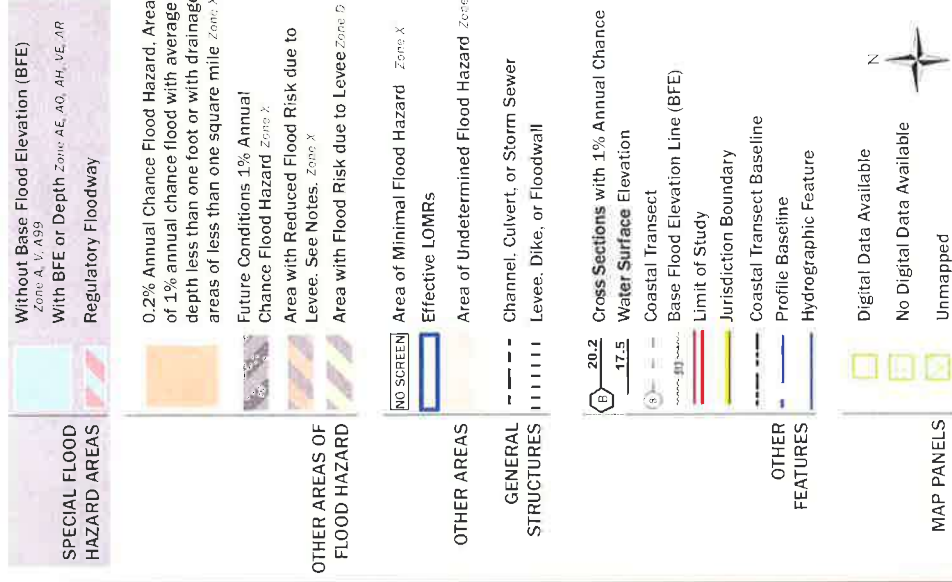
National Flood Hazard Layer FIRMette

The pin displayed on the map is an approximate point selected by the user and does not represent an authoritative property location.

This map complies with FEMA's standards for the use of digital flood maps if it is not void as described below. The basemap shown complies with FEMA's basemap accuracy standards.

The flood hazard information is derived directly from the authoritative NFHL web services provided by FEMA. This map was exported on 10/8/2018 at 5:11:19 PM and does not reflect changes or amendments subsequent to this date and time. The NFHL and effective information may change or become superseded by new data over time.

According to the site's FEMA Flood Insurance Rate map (FIRM) indicates that there is a 100-year flood zone in the area at EL 160. See Appendix B for FIRM map.

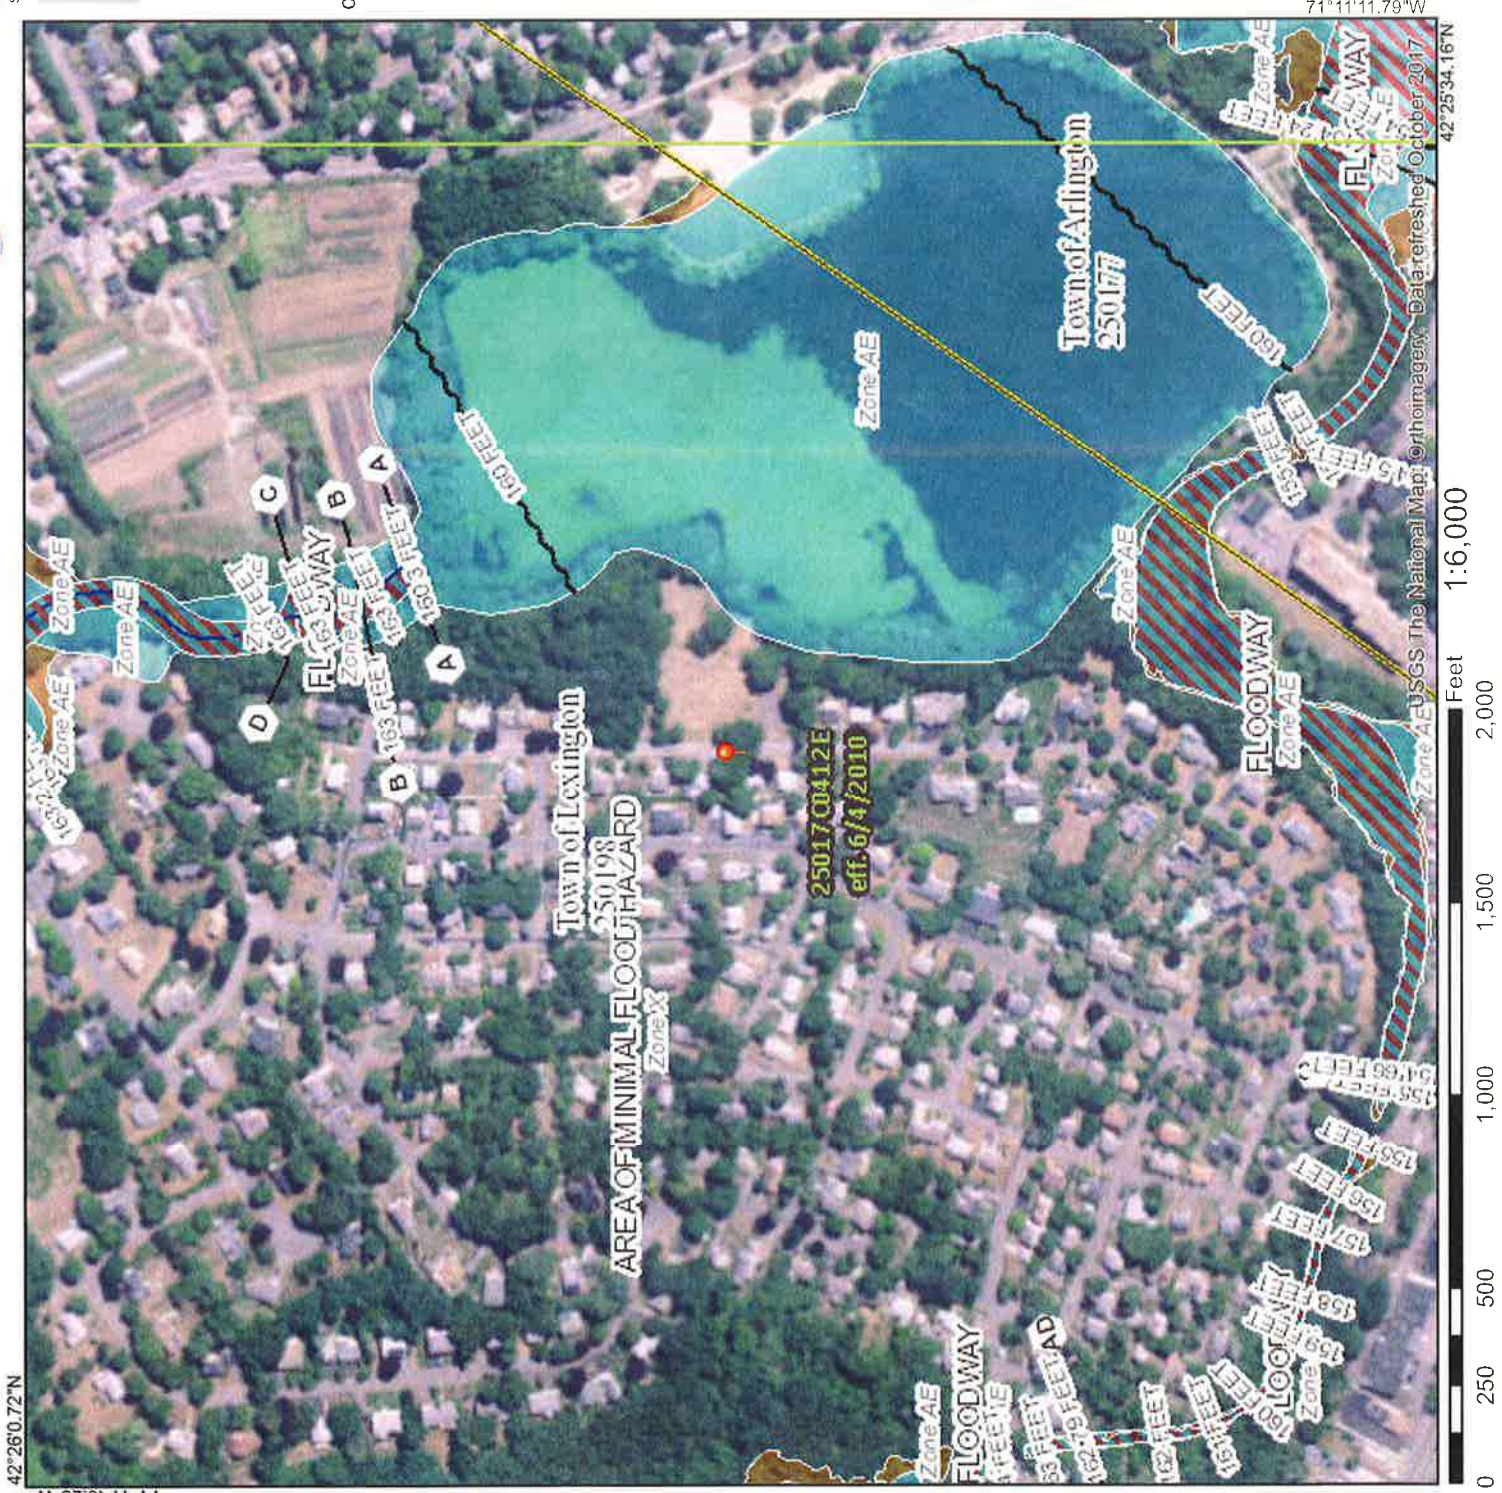
FIGURE 4
FEMA FIRM Map

Additionally, a FEMA Flood Insurance Rate Map (FIRM) was created online from the FEMA website to determine if there is a 100-year flood zone at the site. See Appendix B for FIRM map. As shown on the map, there is a 100-year flood zone in the investigation area.
