Arlington Reservoir Master Plan

2018

INTRODUCTION AND EXECUTIVE SUMMARY

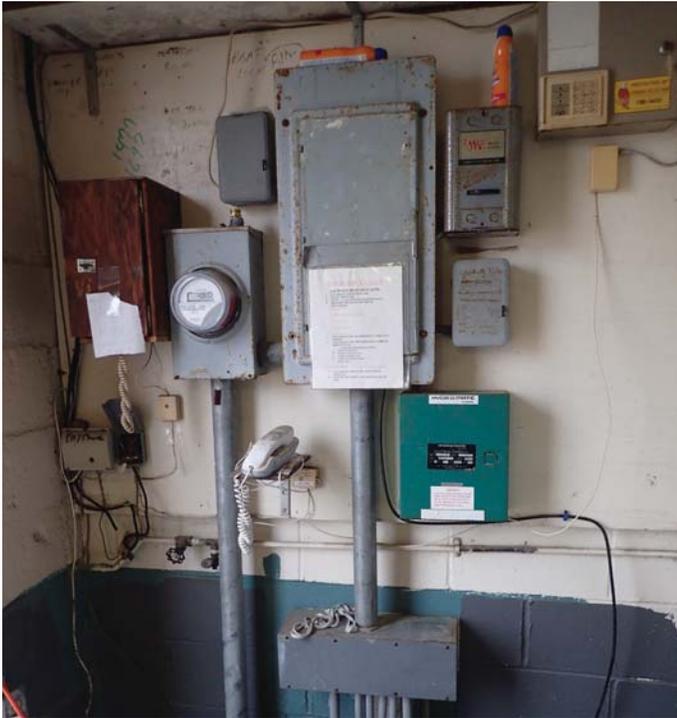
were not evaluated as part of this assessment. No known issues were reported. Interior lighting is by fluorescent tubes in moisture-resistant enclosures. Light levels in the Men's and Women's rooms were poor. Exterior lighting fixtures are outdated, but have been fitted with replacement LED bulbs.

Electrical system within the bathhouse & concession

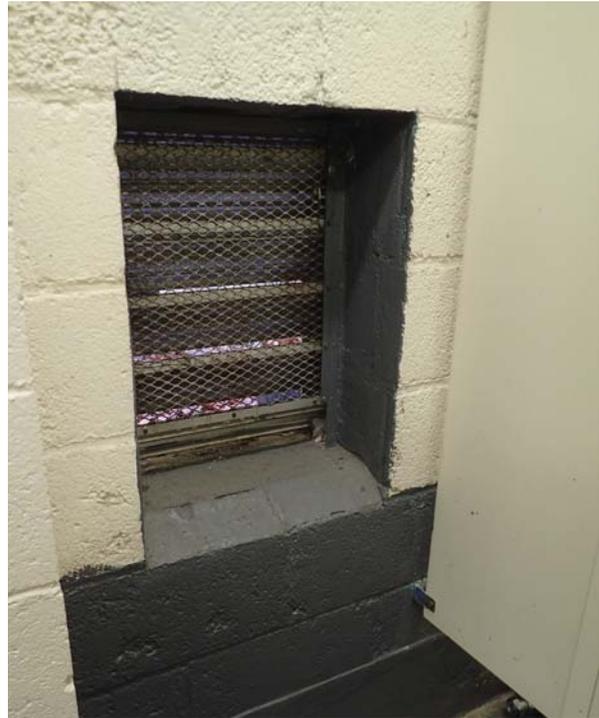
Passive intake louvers within the bathrooms

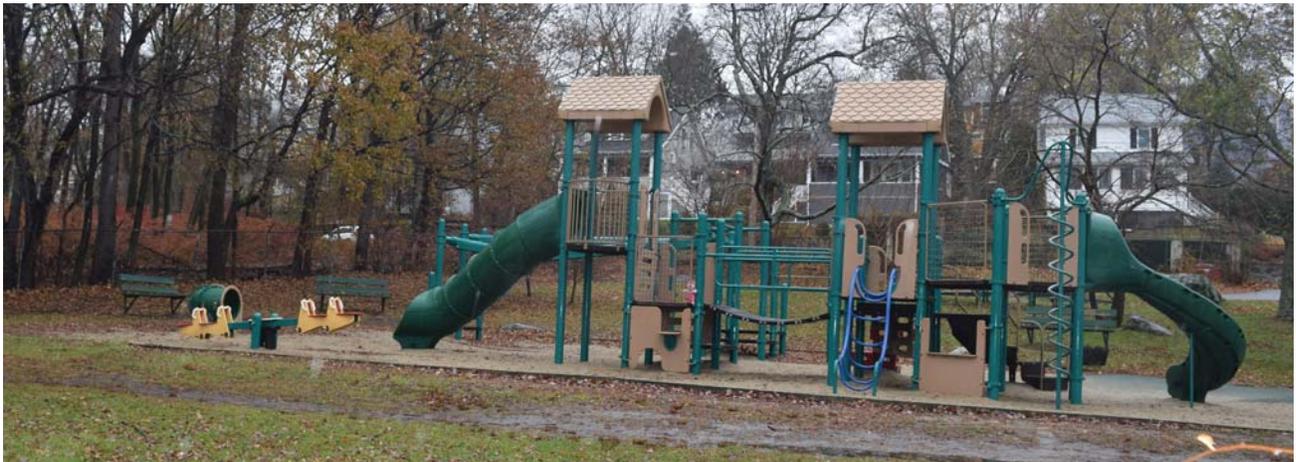
Large play structure

A small play area and individual play pieces are located within the limits of the bathing beach, which make them unavailable to the general public and neighborhood during beach season. The large play structure shown above serves children from ages 5 to 12 years old and offers multiple slides, a wobbly bridge, climbers, a zipline, and space for imaginative play. There is also a seesaw, a tunnel and benches included within this play zone. Although an accessible route is provided to this large play structure, the surfacing material is generally sand, which is not ADA-compliant. A 2-to-5 year play structure with a slide, a free-standing set of overhead bars and a swing set all sit within separate zones of sand and do not meet Certified Playground Safety Inspector (CPSI) standards. All of these structures are at least fifteen years old and have reached their maximum life expectancy.

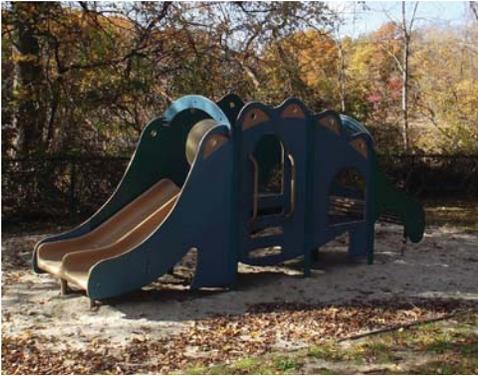
2-5 play structure on sand

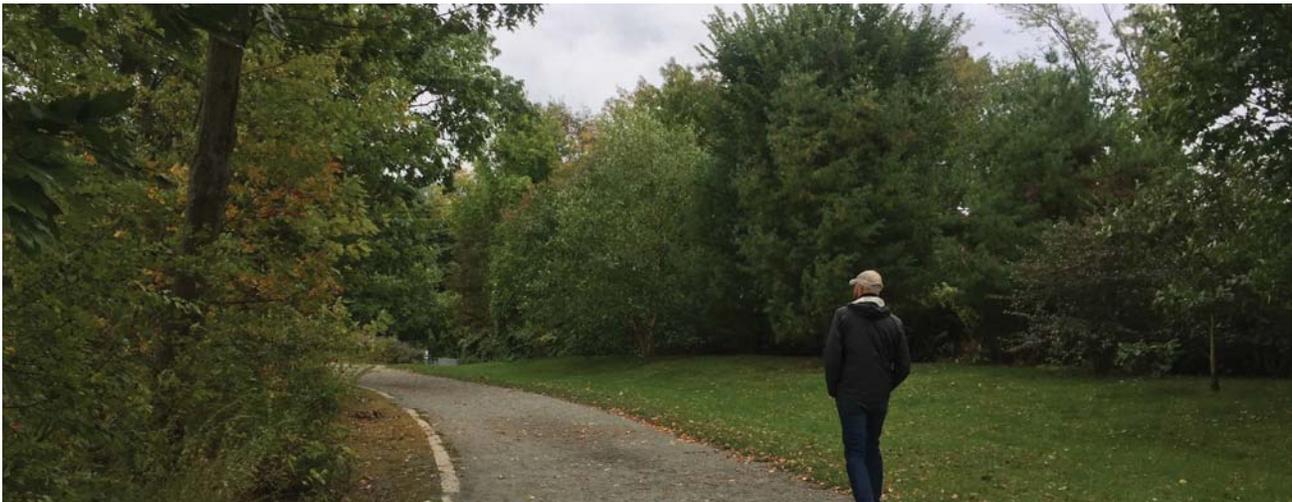
Trail condition near the Drake Village Complex

- The perimeter trail condition is wildly variable and lacks consistent accessibility. Trail improvements should address tree roots, ensure positive drainage away from the paths and establish a typical and consistent width along the entire trail.

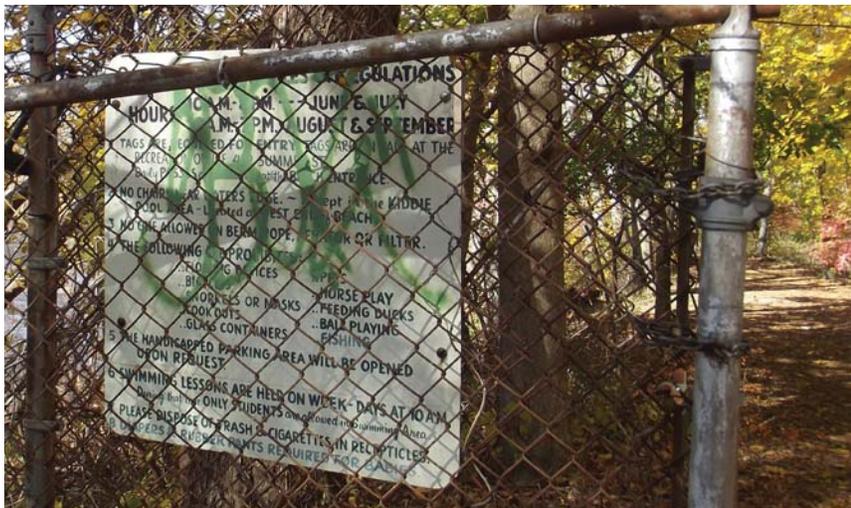
Bathing beach rules and regulation signage

Signage hung from the perimeter fence surrounding the bathing beach displays rules and regulations that pertain to use of the beach. This signage has been vandalized and could be located more prominently as part of the improvements to the beach. Finally, a large upright sign at the Wildlife Habitat Garden describes information about the garden, including the plants growing there and why they were chosen. As is the case with all of the signage within the entire property, this sign has its own aesthetic and is distinctly different from the other large kiosk signs located at the trailhead described above.

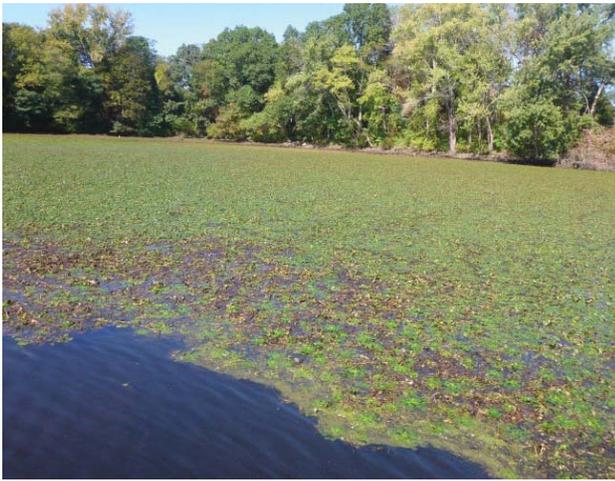
Aquatic Plant Community - The rooted plant community is a dominant feature of The Res and is comprised primarily with three species: water chestnut (*Trapa natans*), Eurasian watermilfoil (*Myriophyllum spicatum*), and coontail (*Ceratophyllum demersum*). The first two are invasive species, and although coontail is native, it has been known to reach nuisance densities. A few other species are present, either as sparse or moderate density growths, including spiny naiad (*Najas minor*), curly leaf pondweed (*Potamogeton crispus*), spiral pondweed (*Potamogeton spiralis*), burreed (*Sparganium* species), and aquatic clover (*Marsilea quadrifolia*). Both the spiny naiad and curly leaf pondweed are invasive species and, while aquatic clover is not native, it does not reach nuisance densities that would qualify it as an invasive species. The rooted plant community of The Res is half invasive species by taxonomic breakdown, but much more than half by biomass.

Water chestnut

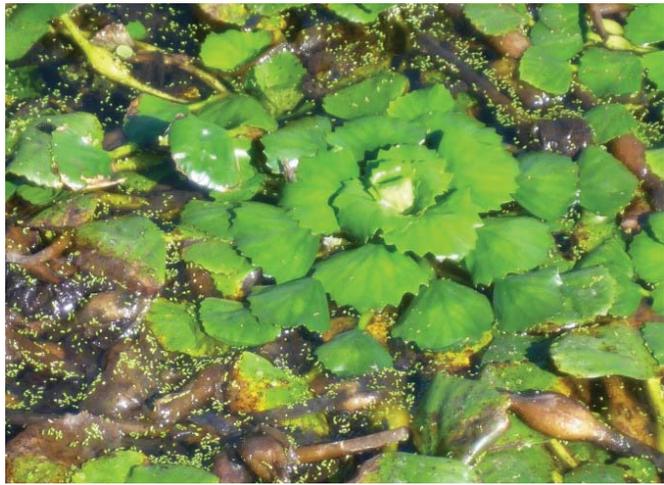
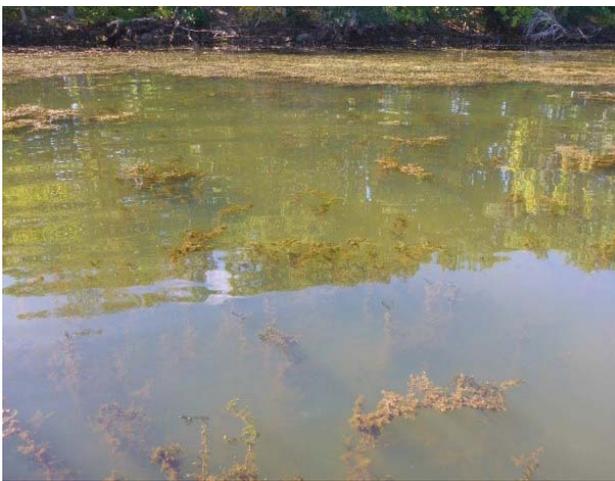
Eurasian Watermilfoil

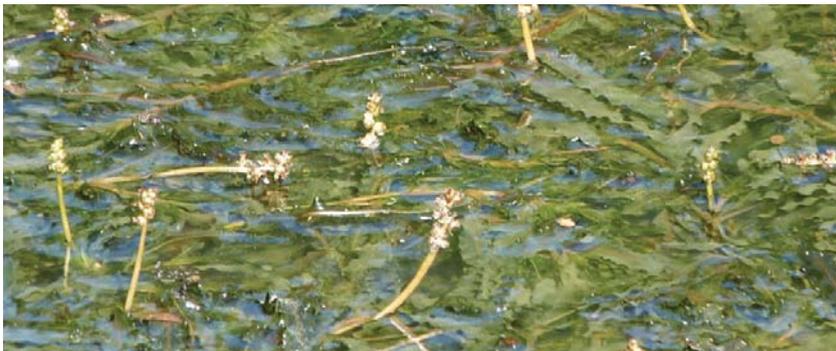
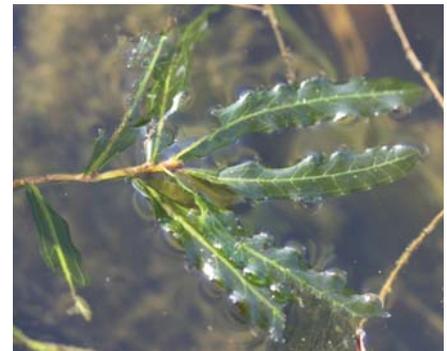
Given that this survey was conducted in late September, it is possible that other species were more abundant earlier in the growing season, most notably curly leaf pondweed, which tends to peak in late spring and die back over the summer. The Res has multiple plant problems that represent the most obvious threat to its designated uses. With a maximum depth of 7 feet, there is no place in the reservoir where plants cannot grow due to depth/light limitations. Only a few areas have coarser substrate that limits plant density. If not for the mechanical harvesting program, water chestnut

Curly leaf pondweed
